2 V.F. SIGNALLING RECEIVER

ISSUE 1 APP 13-4-70

ORIGINATED BY GEC/AEI.

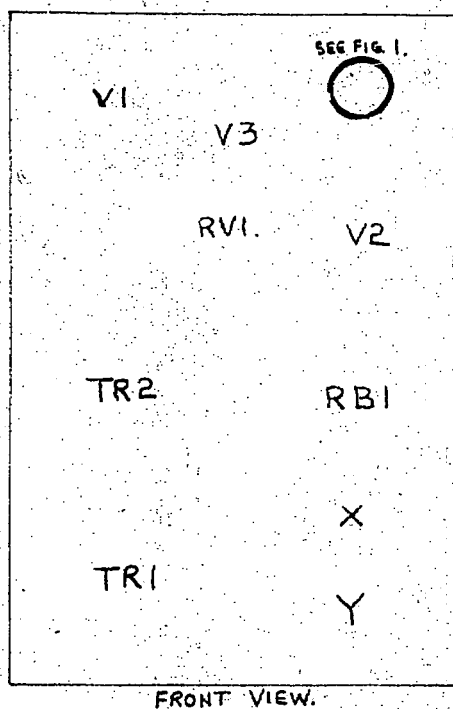
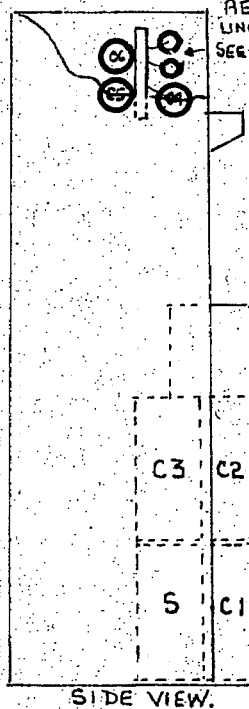
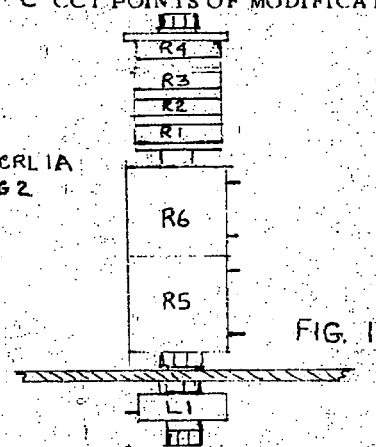
LAYOUT

RELAY	BCC CODE	DIAG. FIG	NOTES	COMP. DESIGNATION	BPO CODE	NOTES
X	HS526		B11 TEST & RE-ADJUST FIGURES. CONTACTS:- PLATINUM-IRIDIUM.	TR1	AEI 213B	
Y	HS526			TR2	AEI 214B	
				RB1	N°1	
				C1, C2	MC101	
				C3	MC106	
				C4	AEI 42 FN	PFT 150V/0.012 10% Z.B (GEC)
				C5, C6	AEI 42 AM	PFT 150V/0.010 10% Z.B (GEC)
				R1-R4	Coil N°15	
				R5, R6	N°9	
				R7, R8	N°26GC	
				RV1		COLVERN CLR 206/95
				V/HOLDERS	N°26	
				V1		MULLARD EF37 OR EQUIV
				V2, V3		MULLARD EL32 OR EQUIV
					3201	PLUG
				AEI + T23201		MTG PLATE
